ALKALI METAL RESISTANT ELECTRICAL DEVICES

W. H. Snavely
R. E. Stapleton
A. J. Krause
Westinghouse Electric Corporation

TECHNICAL REPORT AFAPL-TR-68-61

June 1968

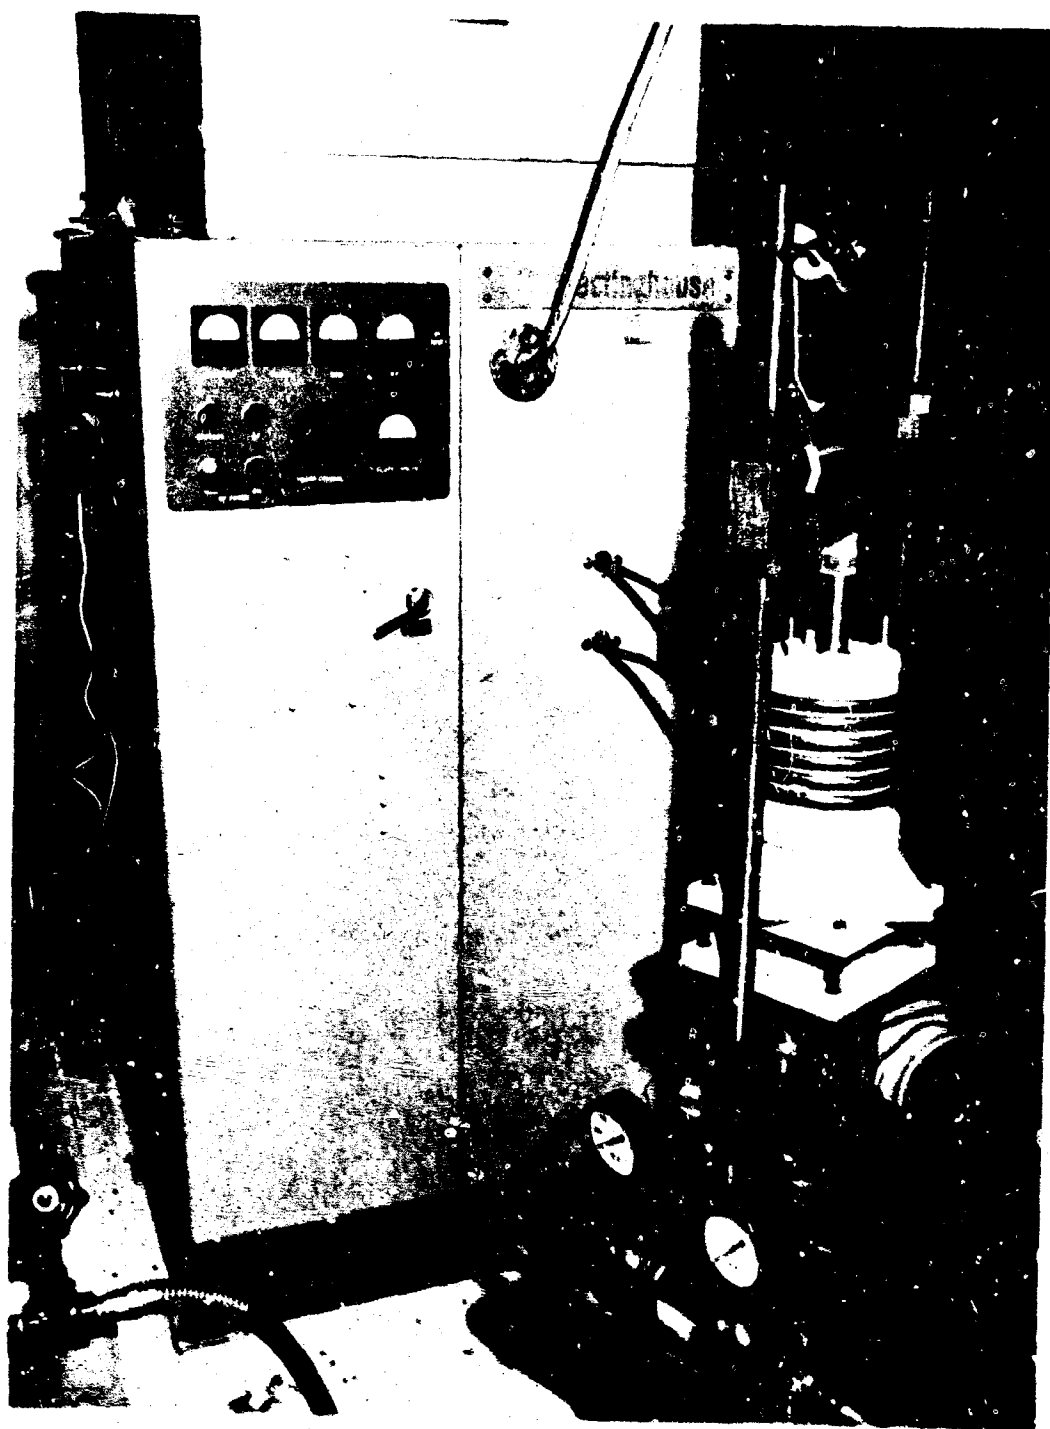
Figure 45. "Floating" Die Hot-Press Assembly and RF Generator

The initial steps used in hot pressing were common to all materials. After the die assembly was loaded with a cold pressed disc it was purged with argon for 30 minutes. A load of 325 psi was then applied and rf heating begun. This load was maintained as the die assembly was heated to 2300°C (as determined with a "Pyro" brand optical pyrometer). The pressure was then increased to 5000 psi and heating continued until a temperature in the range from 2500° to 2700°F was reached. At constant temperature and pressure the change in thickness of the compact was measured over a period of time from about 15 to 30 minutes. When the rate of change in thickness began to approach zero the temperature was raised an additional 25° to 50°F and held for another 10 to 15 minutes. If the thickness decreased substantially after this temperature increase a longer holding time was employed or the temperature was raised an additional increment until no further decrease in thickness could be observed. All materials processed in this manner had high densities and fine grained microstructures.

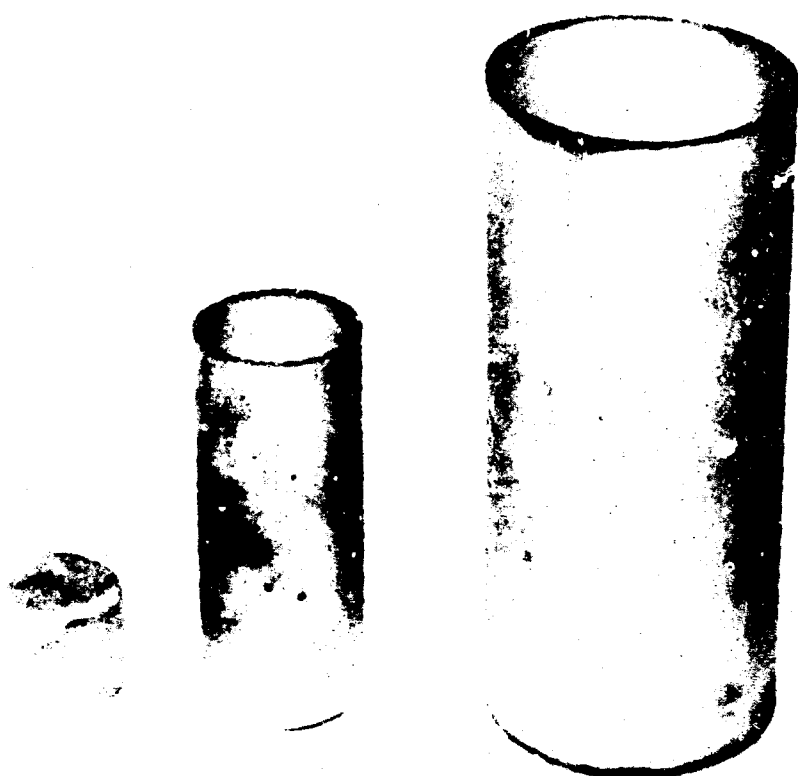
Figure 51. Crucibles Used in Aluminum Oxychloride Preparation

After mixing, the slurry was poured into a graphite crucible and dried in an air oven at 150°C for one hour.

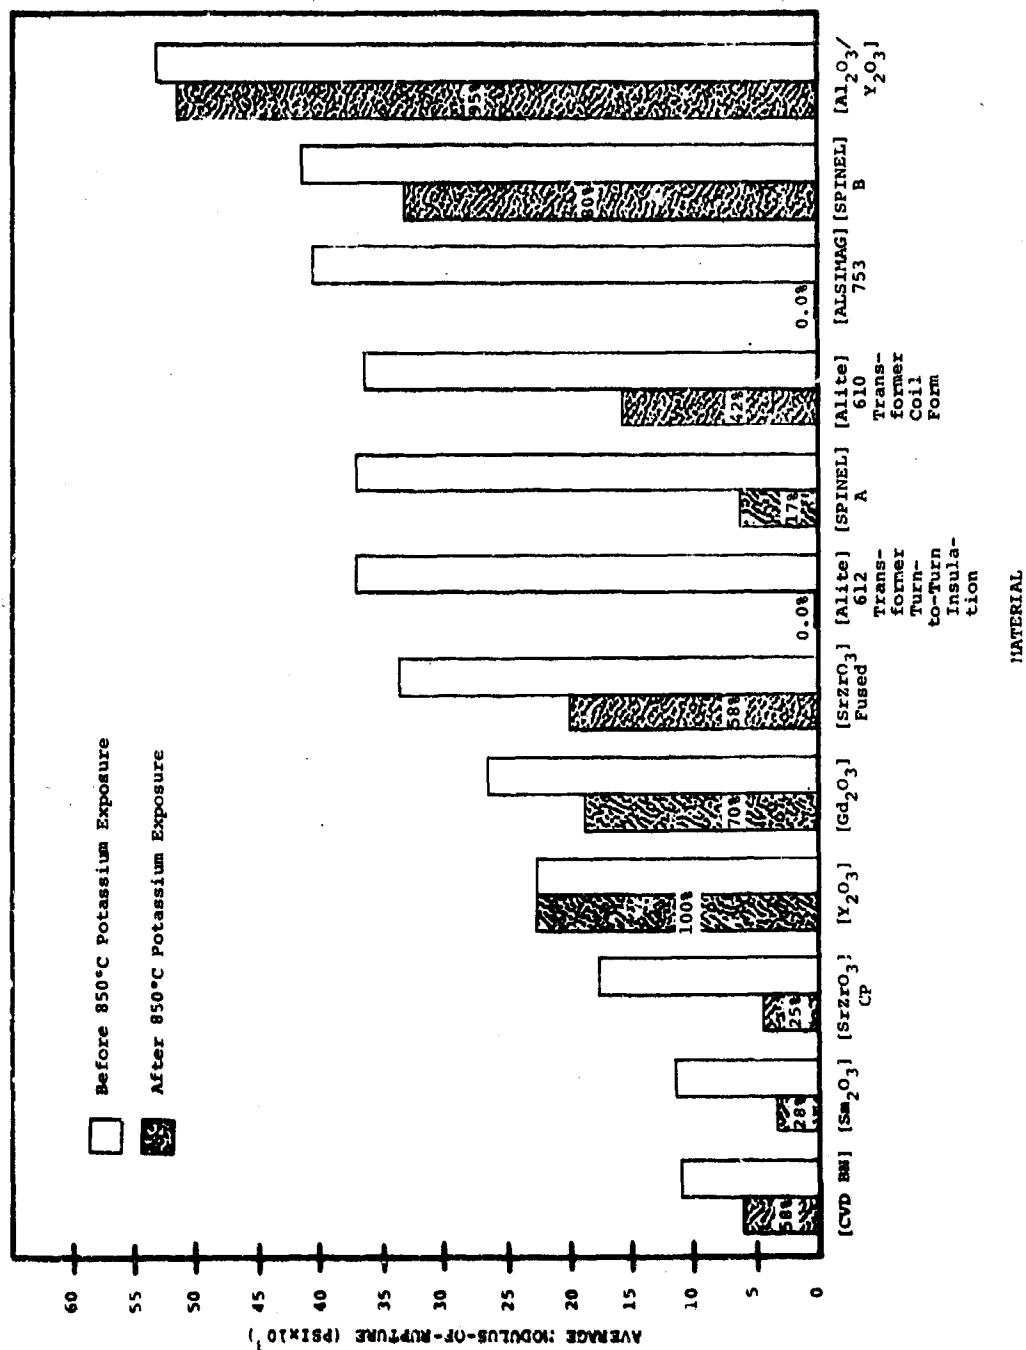
Figure 60. Comparison of Ceramic Materials (MOR bars) Before and After Exposure to 850°C Potassium Vapor for Approximately 200 Hours

Modulus-of-rupture tests were run on purchased and Westinghouse fabricated ceramic MOR bars both before and after short term potassium vapor tests. Table XXV gives statistical data on these tests and figure 60 shows absolute and relative MOR values.
